Marine Safety Forum – Safety Flash 15-19

Issued: 26th June 2015

Subject: Daughter Craft – Man Overboard Incident

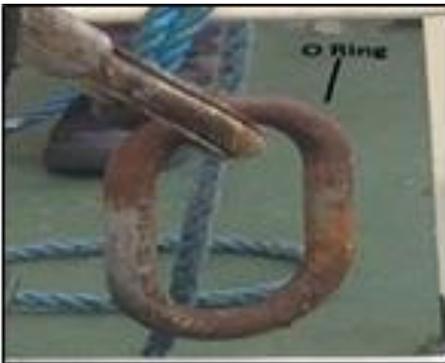
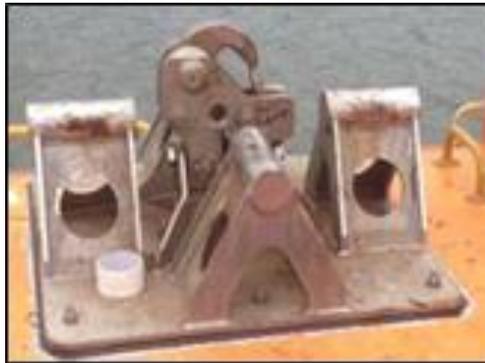
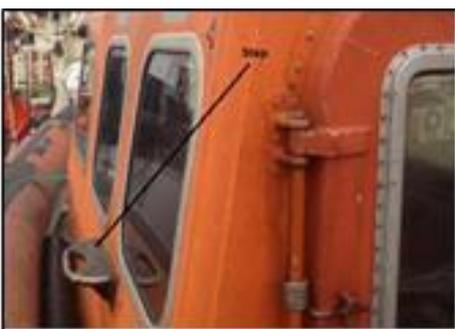
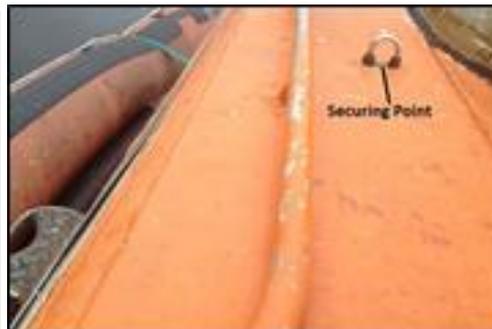
The boatman had moved forward, attached his safety harness to the securing point in the bow of the DC, and collected the bowline from the vessel. He then attached the bowline to the DC, unclipped his harness and moved aft to get the davit O ring in order to connect it to the DC Cranston hook.

Once in position at the aft end of the DC the Boatman climbed up onto the step to receive the 'O' ring but did not secured his harness to the securing point on top of the DC.

He got hold of the 'O' ring and insert it into the Cranston hook. At this point the vessel rolled to stbd causing the davit wire to tighten and pull the DC. He was caught off balance and fell into the water. He was recovered to the DC uninjured; however he spent an estimated 10 minutes in the water. On return to the mother craft he was checked by the AMA given a change of clothing and a hot drink.

- PPE not used as required;- not clipped on, however there were no reported defects with the PPE utilised
- The crew of the DC were experienced in the launch and recovery of the DC and FRC.
- This was a routine operation in good conditions and an opportunity to assess and train the crew.
- The DC is fitted with fixed securing points for clipping on harnesses not slide rails as fitted to most DC's.

- The Boatman did not secure his safety harness to the harness point and did not convey this to the deck crew.
- Deck crew lowered the davit wire without confirmation of the Boatman being secure.

Failure to clip on is a breach of our safety procedures; however we do know that people do not go out of their way to be involved in an incident or get injured. We also know the majority of people do not purposely break the rules or disregard procedures. In this case it is considered that a slide rail securing system would have been used if fitted.

- Safety Coach to attend sea trials, witness launch and recovery exercises and coach and advise as necessary
- Specific Time out for Safety meeting to be held on-board to discuss the incident
- Crew to be made aware of PPE responsibilities
- Investigate retro fitting of slide rails.

Note, since this incident slide rails have been fitted to all DC's in the fleet.
